Manhole Inspection Summary

Manhole # S21M__048MH

Insp Date: **2/24/09 11:46 AM**

Location Address: **549 S MONROE ST**

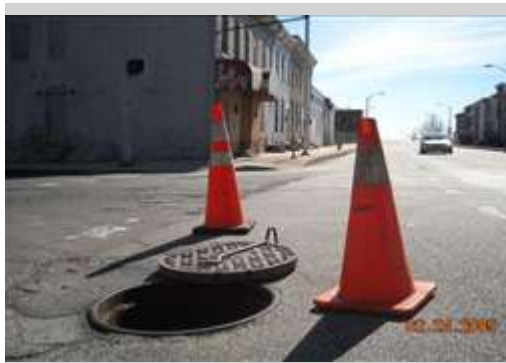
Location View

Comments **HEAVY CLEANING FROM DOWN STREAM MANHOLE S21M__022MH TO REMOVE GREASE DEPOSITS AND ALEAVIATE SURCHARGE; ASPHALT IS CRACKED AND DETERIORATED AROUND FRAME**
